# Case Study: ZERo100 Erosion/Corrosion Protection

## Summary: Cost Reduction in OPEX (Rod, Pump, and Tubing Failures)

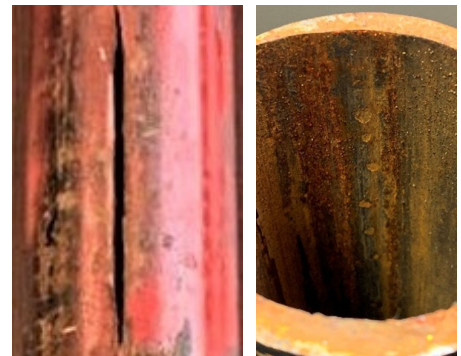
A midsize operator in the Montney Formation was having cost overruns due to workovers caused by repeated rod replacements and pump failures. During the inspection of the tubing, the operator also discovered extensive erosion and corrosion with major wall loss on the tubing.

Tubing Failure and Erosion

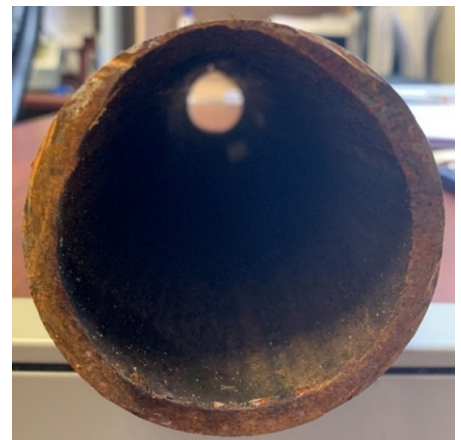
Major Wall Loss
