# Case Study: ZERo300

## Erosion/Corrosion Protection

### Summary: Cost Reduction in OPEX (Rod, Pump, and Tubing Failures)

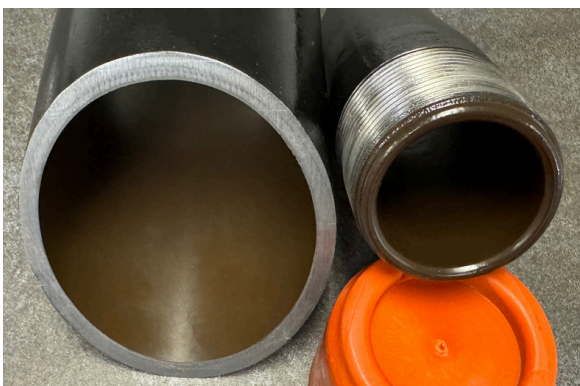
**ZERo300 Coated Tubing**  
(Orange Band)

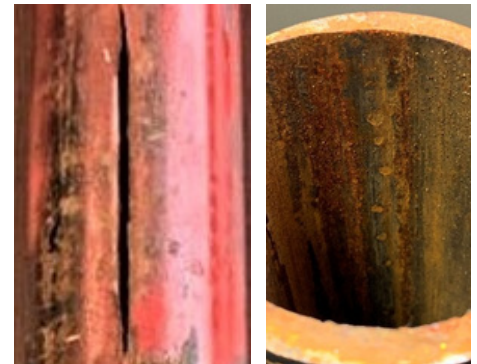
Tubing Failure and Erosion

A midsize operator in the Montney Formation experienced cost overruns due to workovers resulting from frequent rod replacements and pump failures. During the inspection of the tubing, the operator discovered significant erosion and corrosion, resulting in major wall loss.

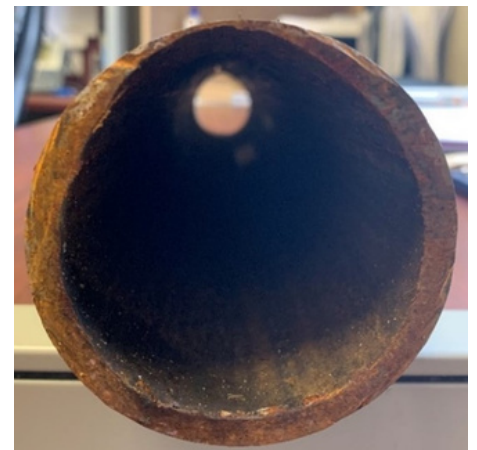
Major Wall Loss
